# Lessons learned from the radiological accident in Mayapuri, New Delhi, India

**Rajoo Kumar**

Atomic Energy Regulatory Board

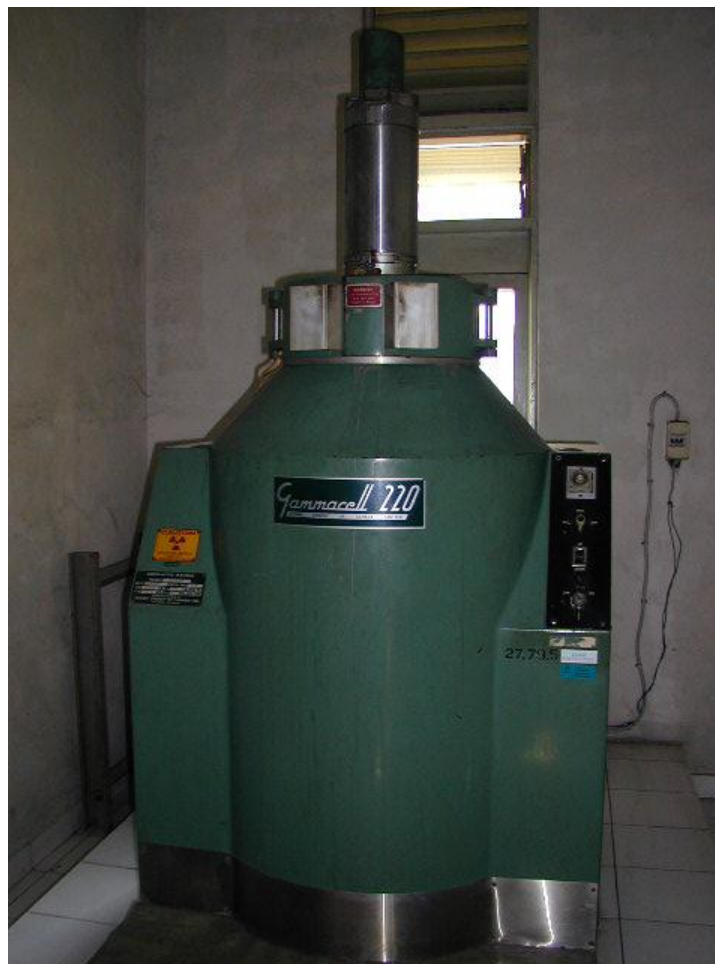
# Category -I Gamma Irradiator of Model Gamma Cell 220

- Gamma Cell ( Model- GC 220)
- Manufactured by M/s Atomic Energy Canada Ltd. (AECL))
- The GC purchased by one of the Departments of a University from M/s AECL in 1969.

- The equipment has a cylindrical cage placed in with 16 pencils (which has a capacity to hold a maximum of 48 numbers of pencils), shielded by approximately three tonnes of lead.

- Each pencil had 7 number of Co-60 slugs and 2 number of dummy spacers. Total activity content of the cell having 112 slugs (16 x 7) was 147.186 TBq (3978 Ci) as of Aug-Sep 1969.

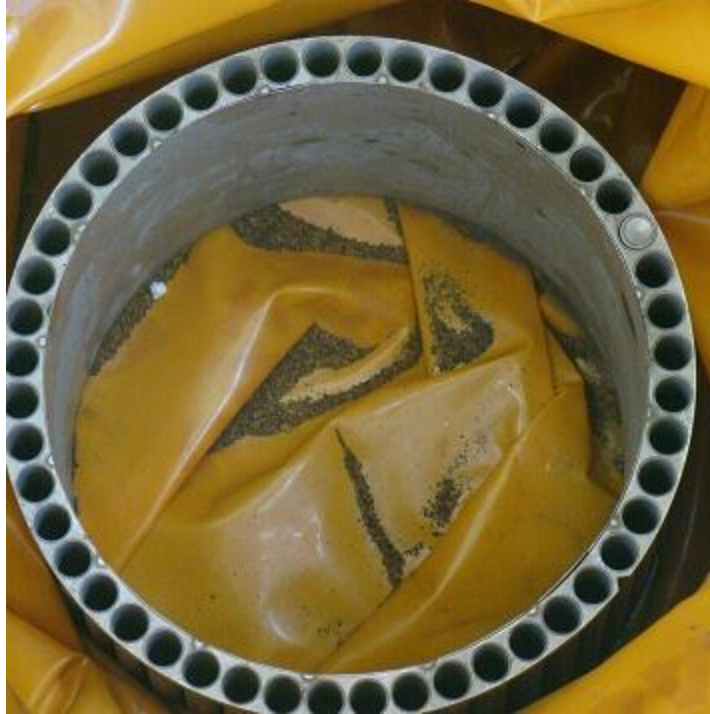
# Photographs of actual source cage and pencil recovered

- Till April 16-17, 2010, the exact application of the source as well as its origin was not known.
- A visual inspection in a hot cell and inspection by autoradiography technique of the sources indicated that the source must have originated from a Gamma Chamber.
- It also revealed that the source cage has 48 slots and the dimensions of the source pencils are entirely different from the indigenous pencils.
- The visual inspection also revealed that there were cut marks on the recovered slugs.

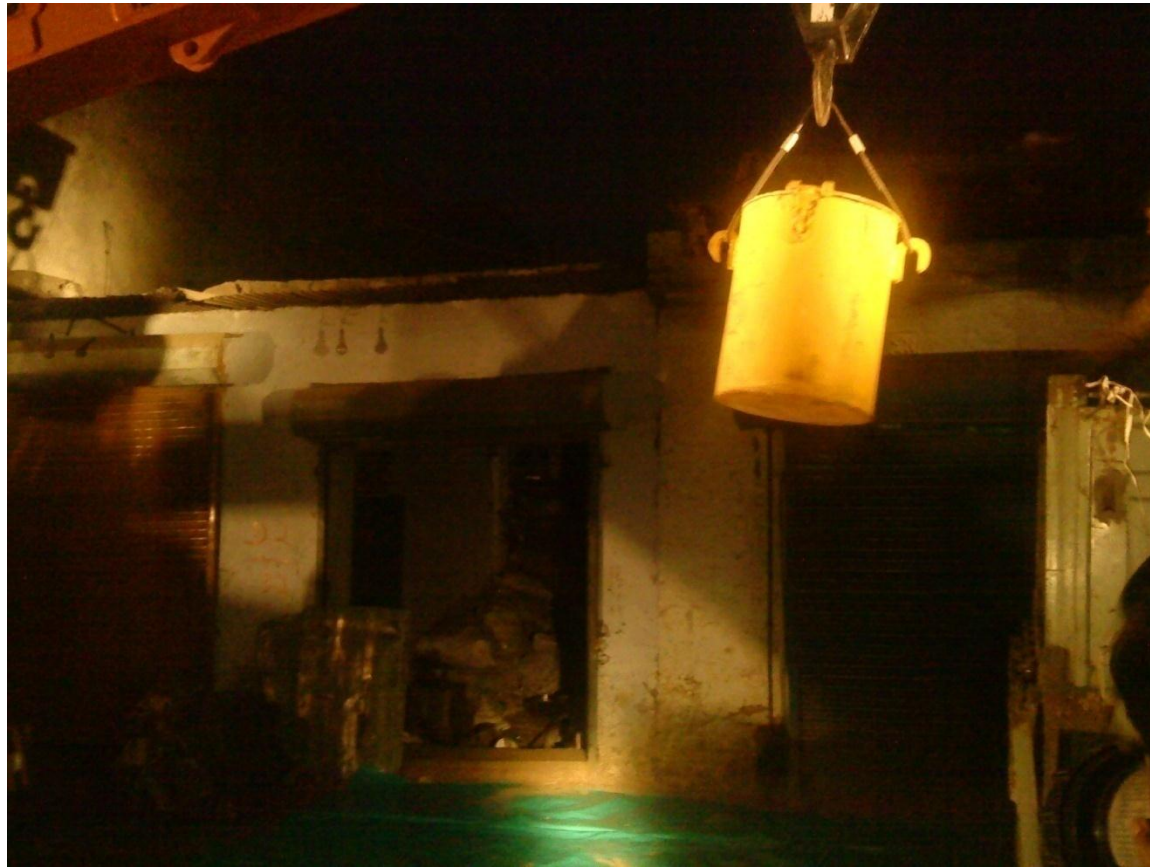
Shielded flask being brought closer to source using crane for safe transfer, 5:40, April 9, 2010

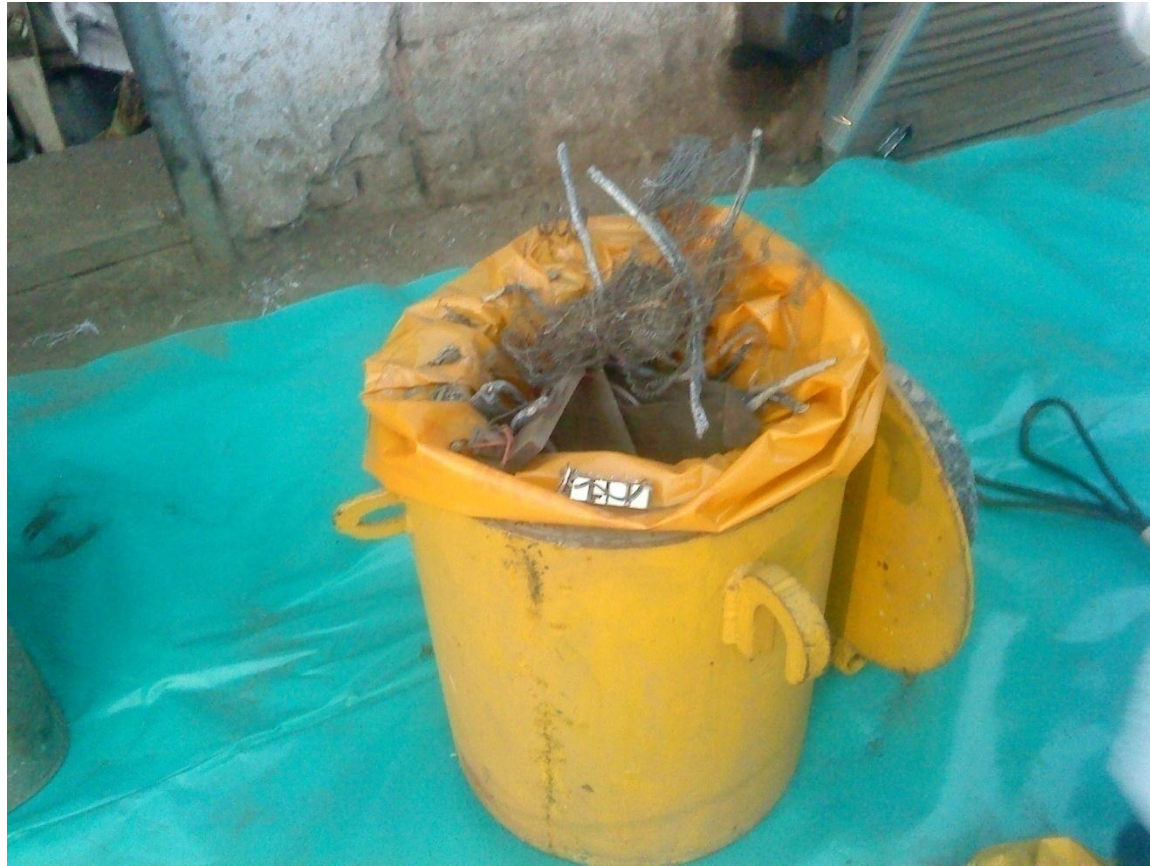
# Scrap with source transferred in shielded flask, 6:15, April 9, 2010

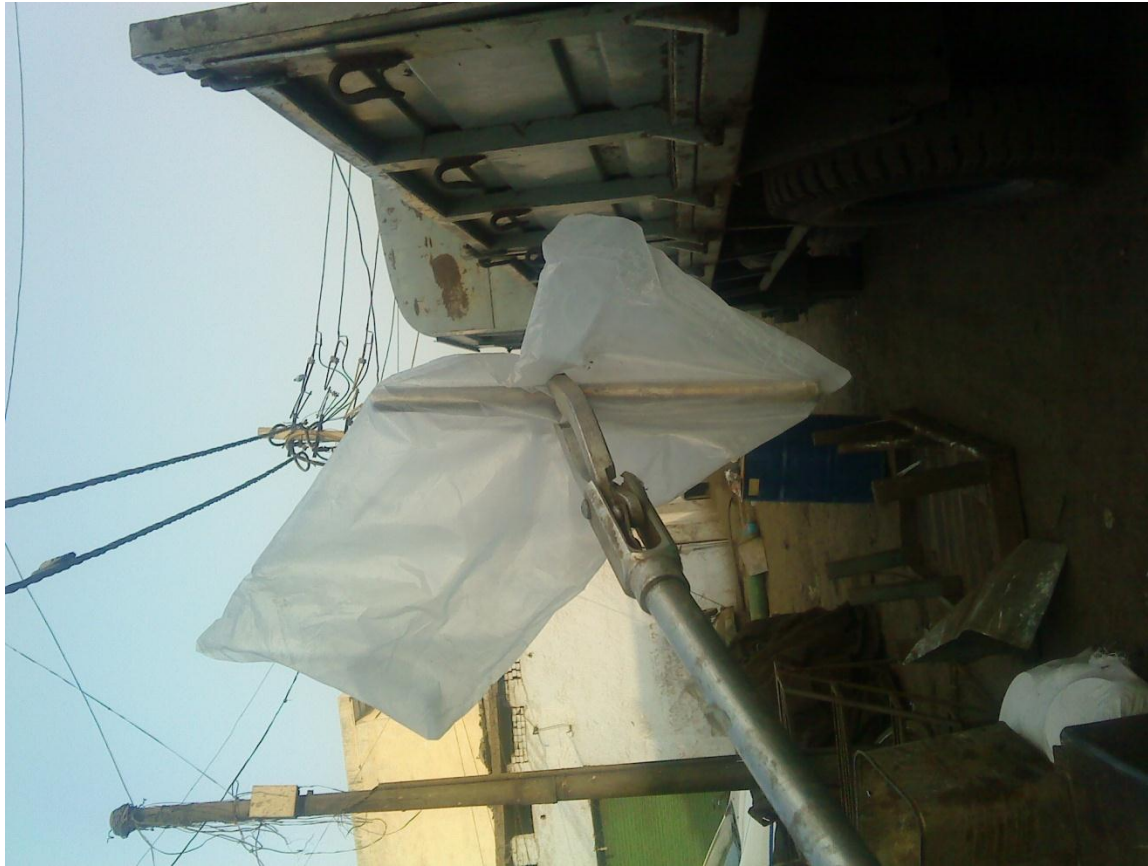
Another source in the form of pencil recovered, 8:30 April 9, 2010

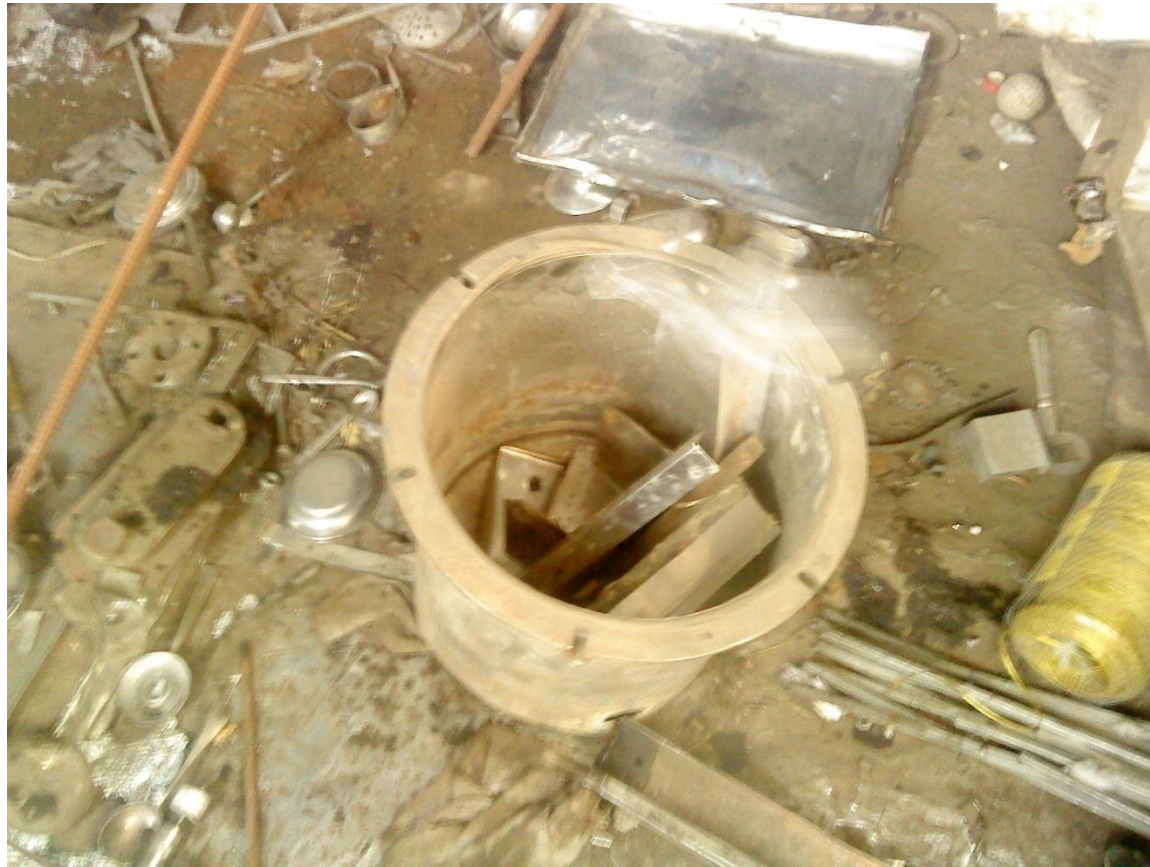
# Another source found in a vessel, 9:00 Hrs, April 9, 2010

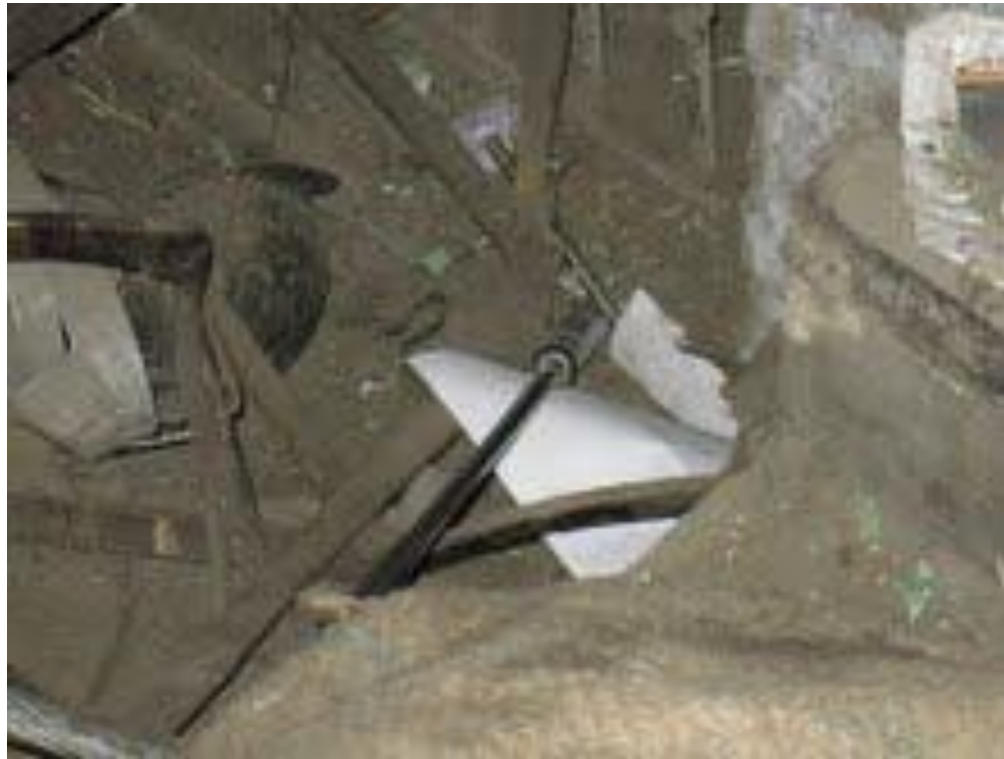
# Co-60 pencil identified, 02:00 hrs, April 14, 2010

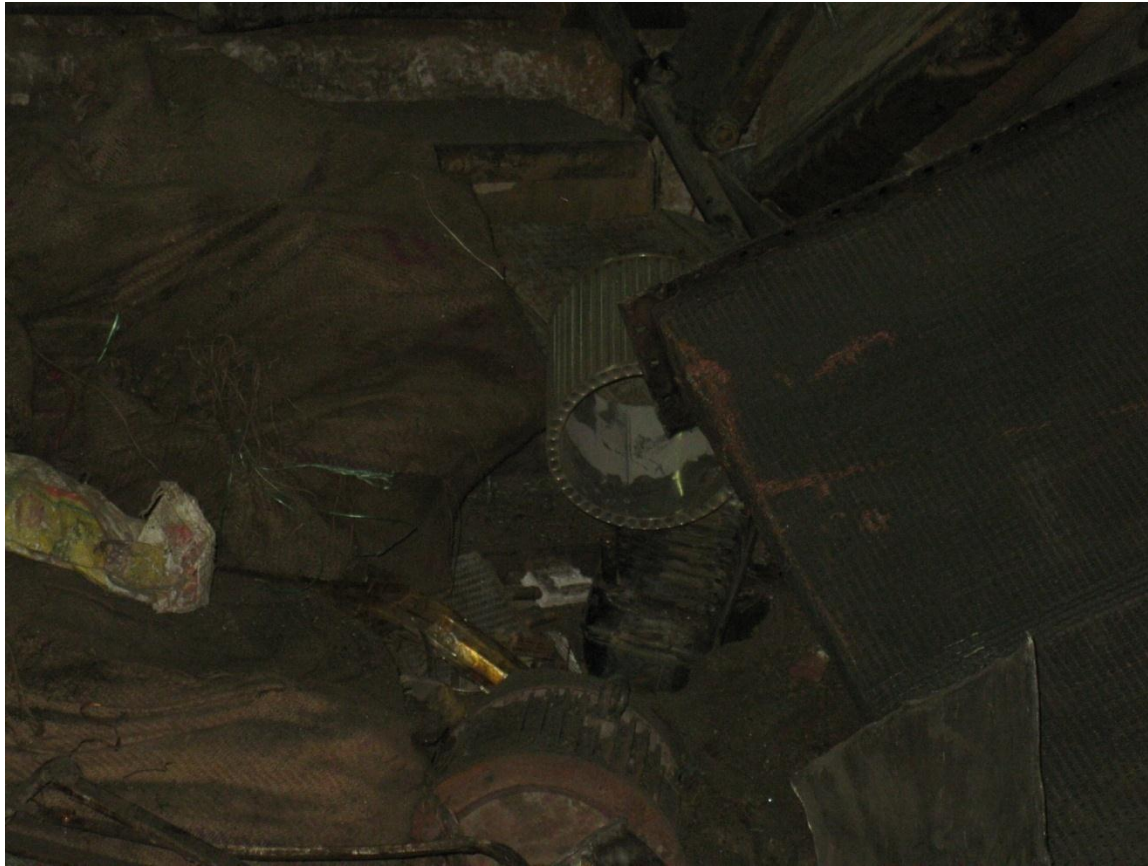
# Source cage identified, 03:00 hrs April 14, 2010

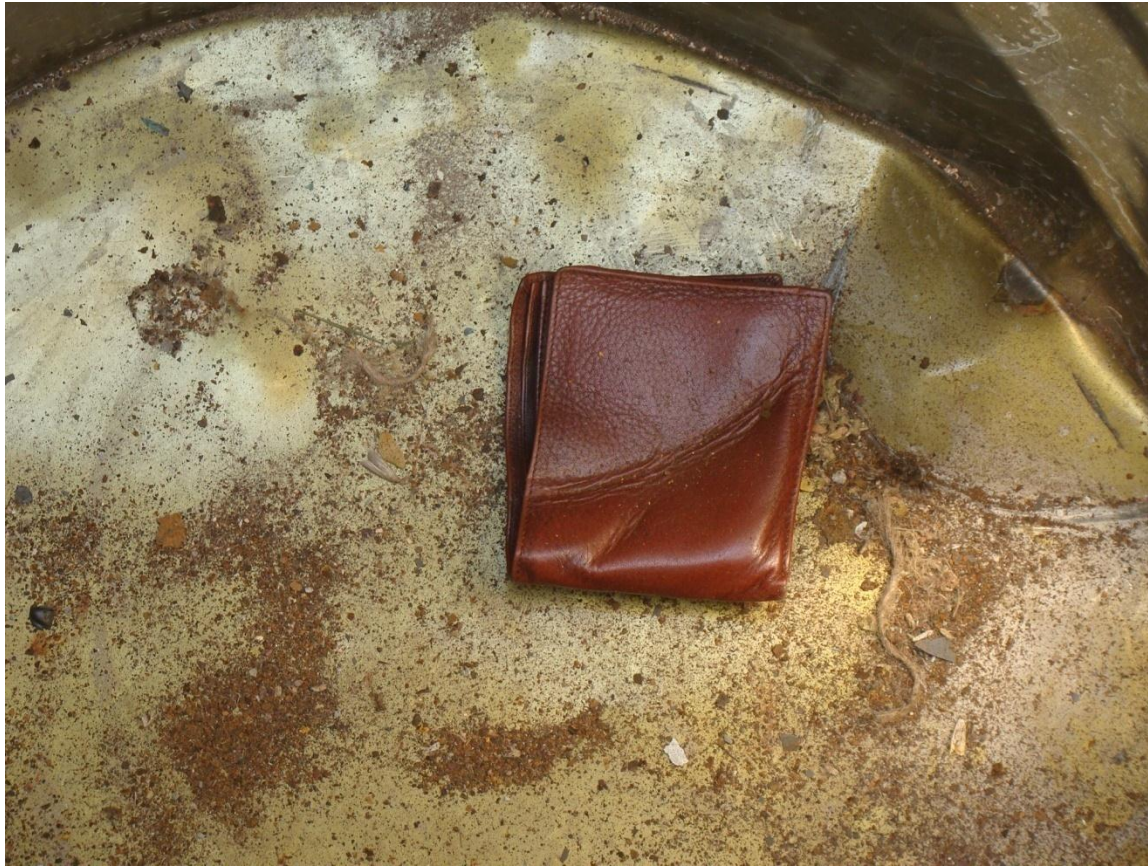
# Wallet containing Co-60 slug, 02:00 hrs April 17, 2010

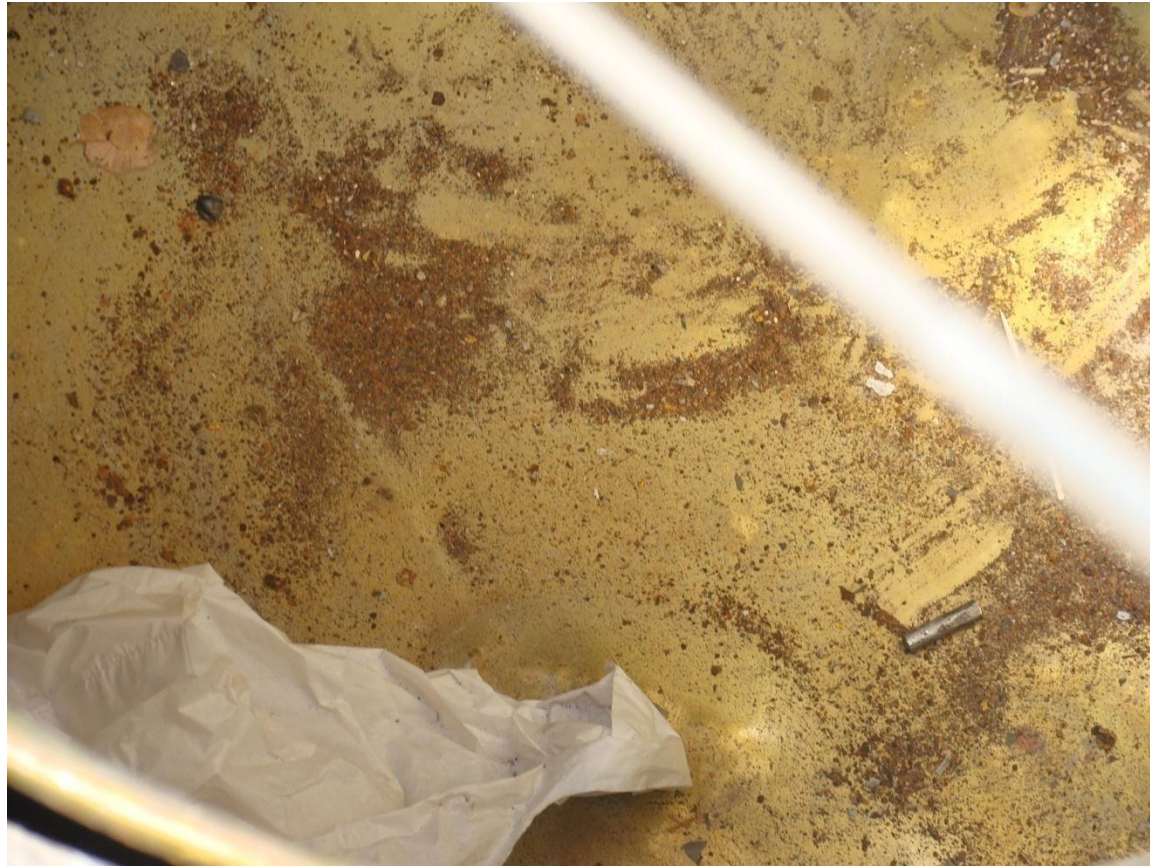
# Slug ( Co-60, 0.75 Ci) which was inside the purse , April 17, 2010

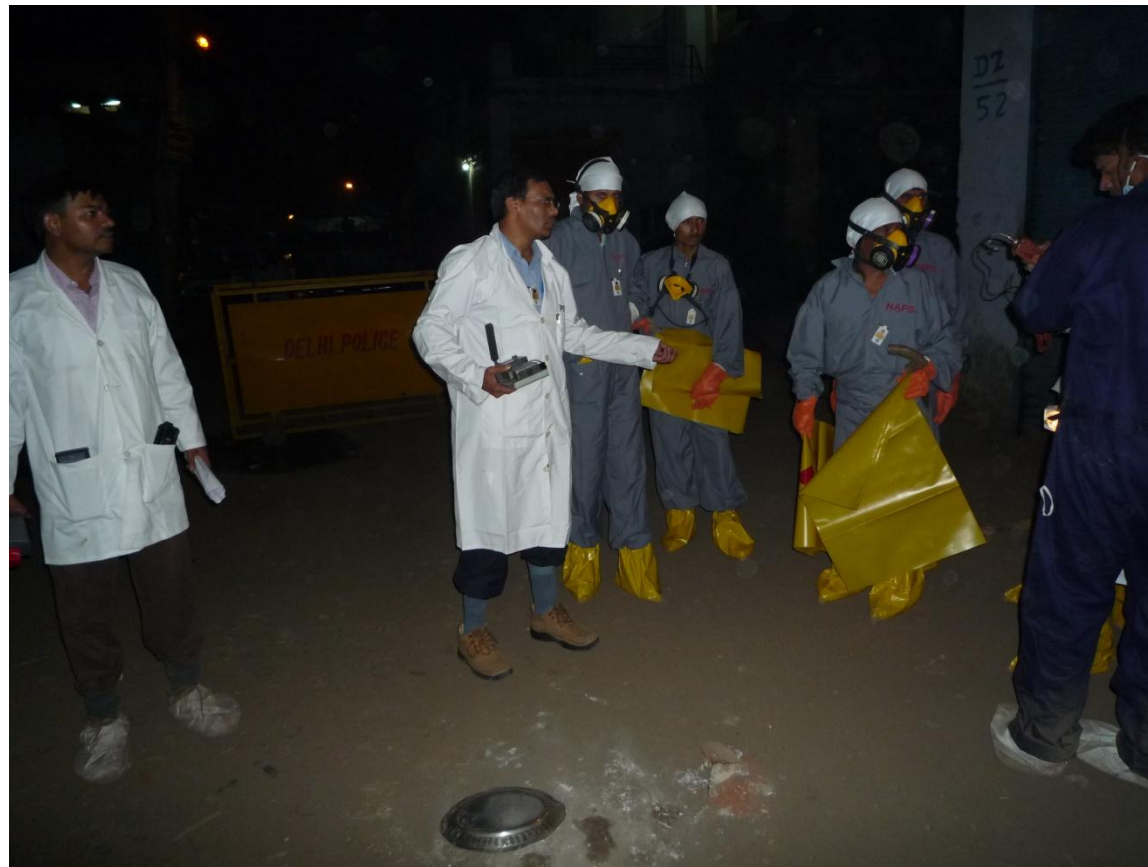
Because of cutting exercise of Co-60 slugs, there was a spread of radioactive contamination around the identified shop

# Contaminated soil being collected, May 15, 2010, Overnight operation

In this entire operation more than 400 kg of contaminated soil and 100 kg of scrap were recovered and safely disposed off at nearest authorised disposal site

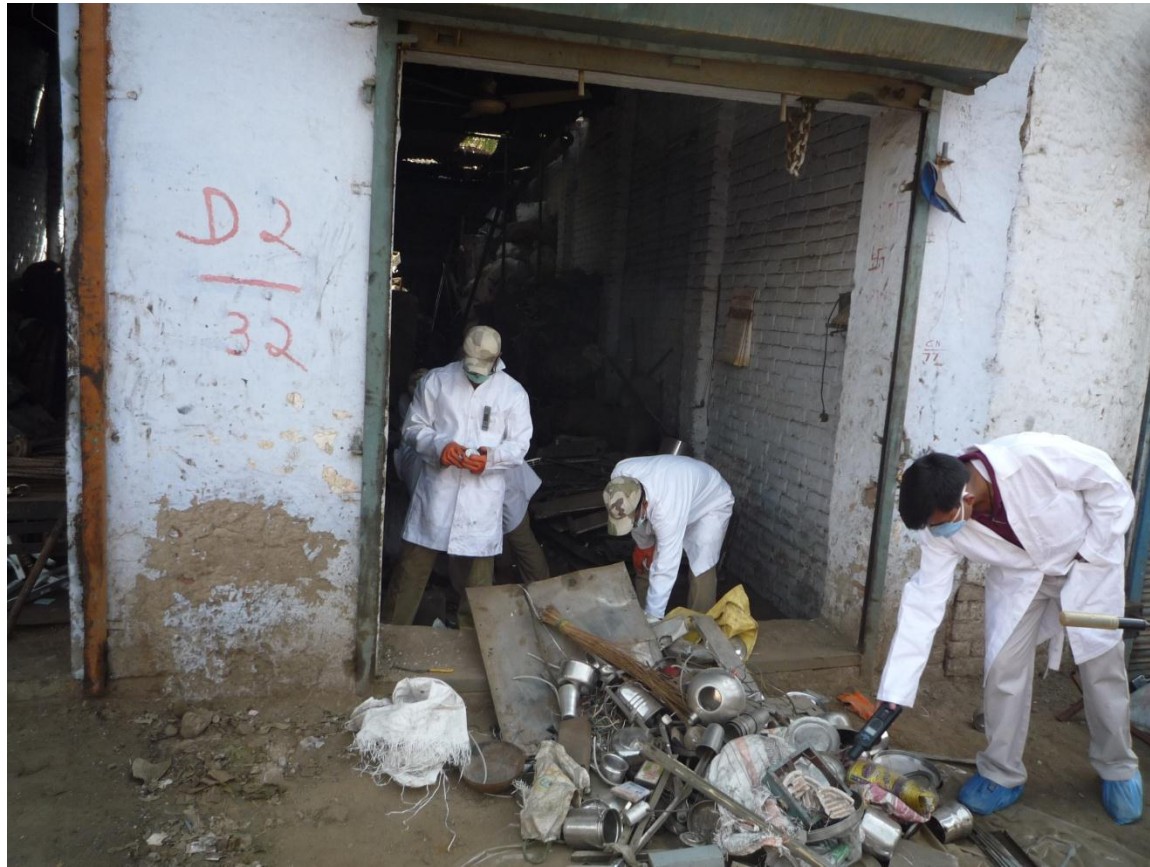
# Scrap being checked for contamination, May 16, 2010

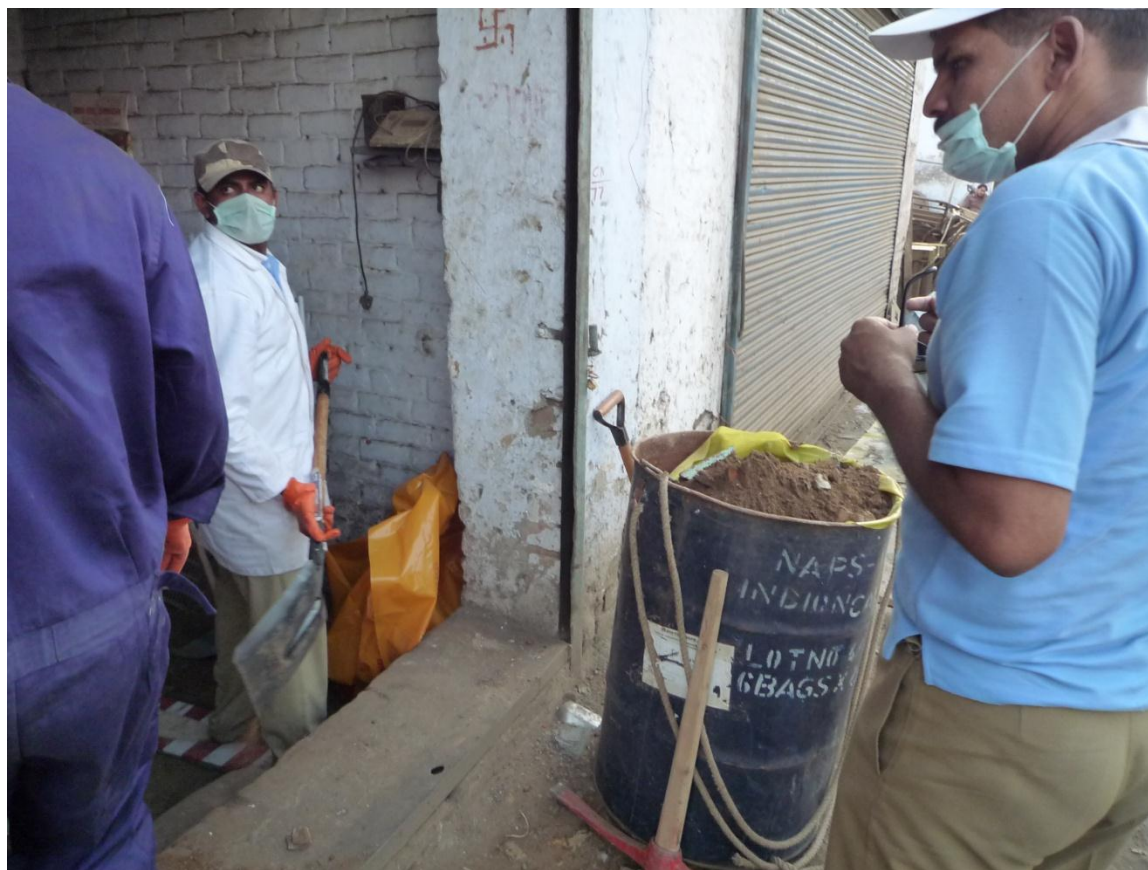
# After excavation contaminated soil collected in drum, May 16, 2010

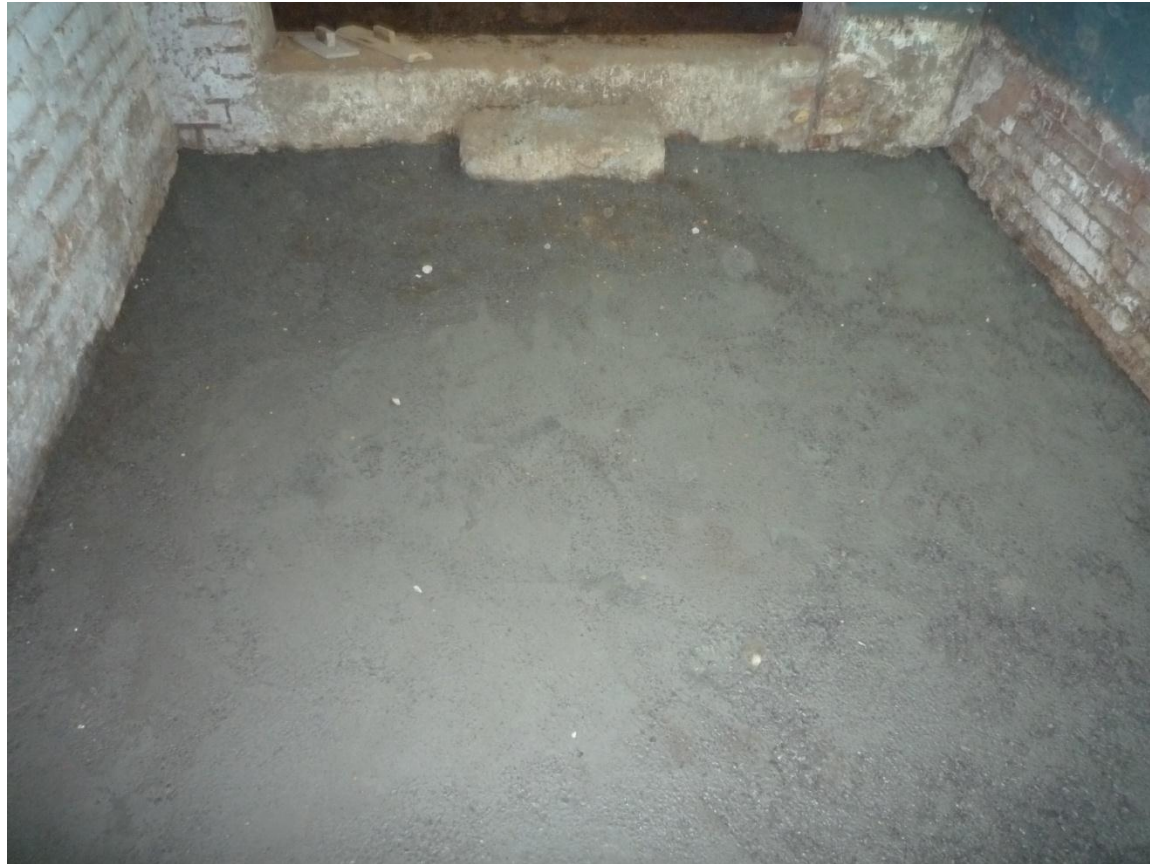
# Concretized 3" thick inside the affected shop, May 16, 2010

- Before decontamination – spots (10-50Sq cm.)
  - 41 spots (100-500  $\mu\text{Sv/hr}$  on contact) – on road
  - 5 spots ( 1000-2000  $\mu\text{Sv/hr}$  on contact) – inside the shop
- After decontamination and concretization – Background level

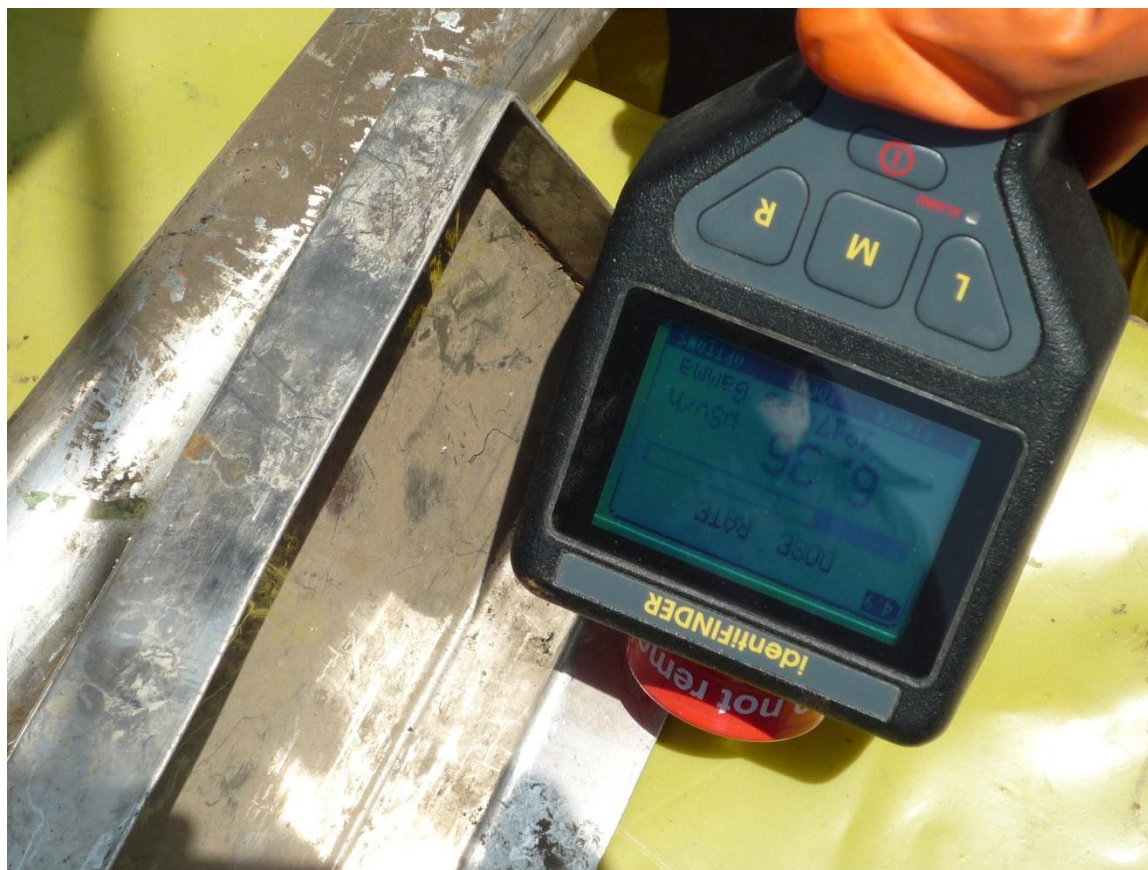
# Contaminated scrap detected, May 22-24, 2010

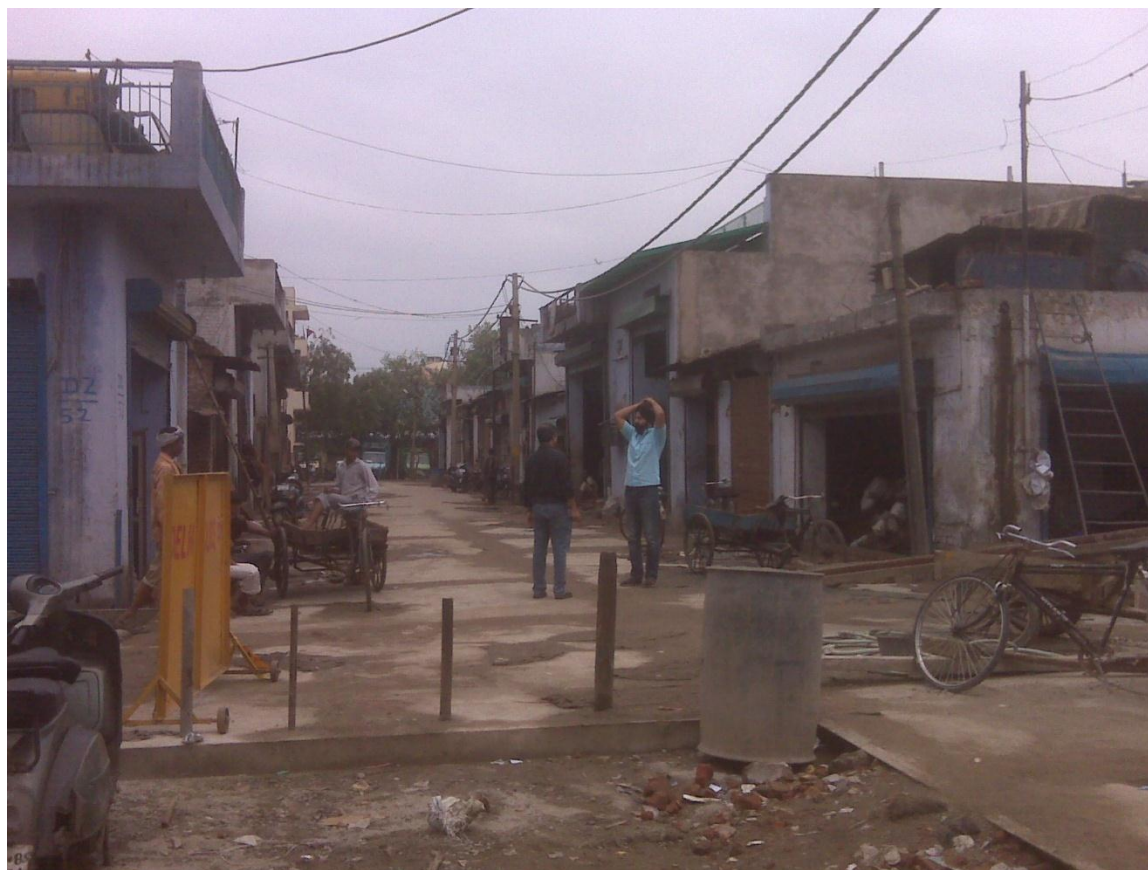
# Affected road concretized after decontamination, June 14-18, 2010
